**Flood Control Project Maintenance
Levee Inspections**
LMA District Cover Sheet
Spring 2017 Levee Inspection Results

Reclamation District No. 1000 Natomas

Spring 2017 Levee Inspection Results

Waterway			Bank	Unit Miles
Unit No. 01 Sacramento River			Left	18.28
	Spring (March - May)	Summer (June - August)	(September - November) Fall	Winter (December - February)
Unit Maintenance Rating (Fall Only)				
Date of Inspection	3/17/2017 - 3/17/2017			
DWR Inspector	Sterling York			
Accompanied By	Don Caldwell RD1000

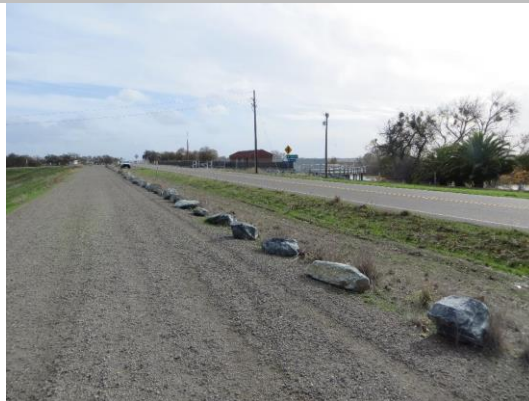
Photo 1 of 3 : UCIP_SP_2017_46974_74887.jpg

LM Start	0.00	Rating **	M	Issue No.	137
LM End	0.00	Issue Type +	En	Location *	WS
Category	Supplemental			GPS Latitude/Longitude	
				Start	End
Item	DWR UCIP Field Study			38.778010 °	38.778010 °
				-121.600766 °	-121.600766 °
DWR ID					
Comment Code					
Inspector Comment					
FS_ID:46974 DS_ID:25354 EP_NO: 16310 Repair Type: Non-Urgent Crossing Status: Found UCIP Comments: FIELD_STRUCT_DESC: 5 of 5. [Sankey Diversion Pumping Plant] 48-inch FS Date: 12/10/2015

Overview of levee crown near Sankey Pumping Station.

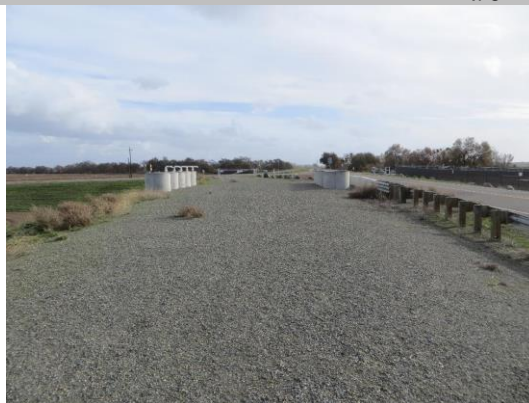
Photo 3 of 3 : UCIP_SP_2017_46974_74889.jpg

Concrete risers located on both sides of levee crown.

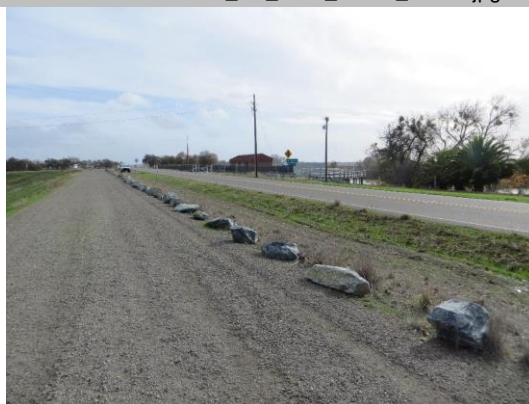
Photo 1 of 3 : UCIP_SP_2017_46970_74867.jpg

LM Start	0.00	Rating **	M	Issue No.	138
LM End	0.00	Issue Type +	En	Location *	WS
Category	Supplemental			GPS Latitude/Longitude	
				Start	End
Item	DWR UCIP Field Study			38.778052 °	38.778052 °
				-121.600805 °	-121.600805 °
DWR ID					
Comment Code					
Inspector Comment					
FS_ID:46970 DS_ID:25426 EP_NO: N/A Repair Type: Non-Urgent Crossing Status: Found UCIP Comments: Need additional as-builts for pump station. FIELD_STRUCT_DESC: 1 of 5. [Sankey Diversion Pumping Plant] 48-inch FS Date: 12/10/2015

Overview of levee crown near crossing.

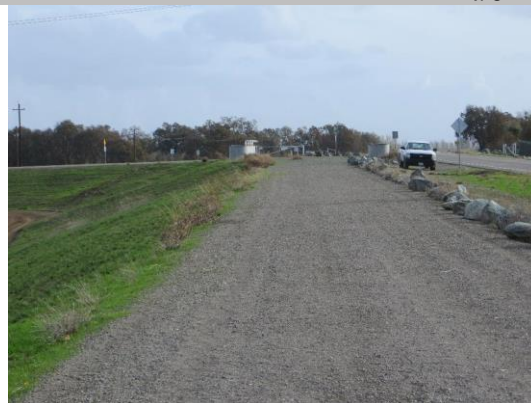
Photo 2 of 3 : UCIP_SP_2017_46970_74868.jpg

View of levee crown looking downstream.

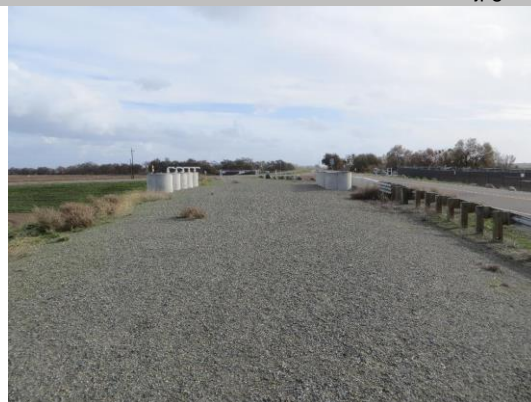
Photo 3 of 3 : UCIP_SP_2017_46970_74869.jpg

Risers visible on both sides of levee crown. Pump station is a vacuum system.

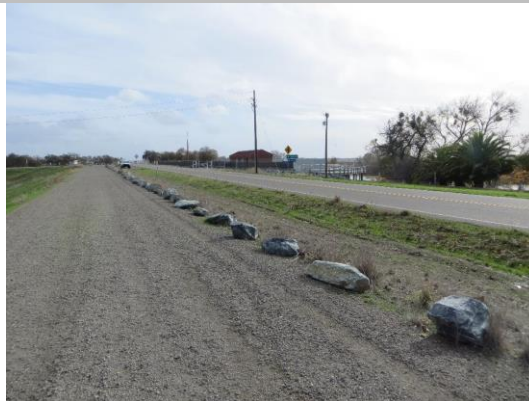
Photo 1 of 3 : UCIP_SP_2017_46971_74872.jpg

LM Start	0.00	Rating **	M	Issue No.	139
LM End	0.00	Issue Type +	En	Location *	WS
Category	Supplemental			GPS Latitude/Longitude	
				Start	End
Item	DWR UCIP Field Study			38.778052 °	38.778052 °
				-121.600805 °	-121.600805 °
DWR ID					
Comment Code					
Inspector Comment					
FS_ID:46971 DS_ID:25427 EP_NO: N/A Repair Type: Non-Urgent Crossing Status: Found UCIP Comments: FIELD_STRUCT_DESC: 2 of 5. [Sankey Diversion Pumping Plant] 48-inch FS Date: 12/10/2015

Overview of levee near Sankey Pumping Station.

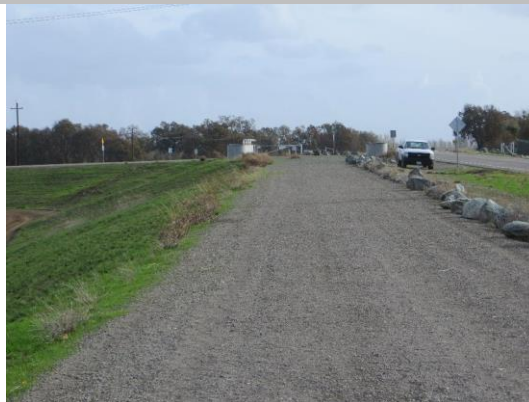
Photo 2 of 3 : UCIP_SP_2017_46971_74873.jpg

View of levee crown looking downstream.

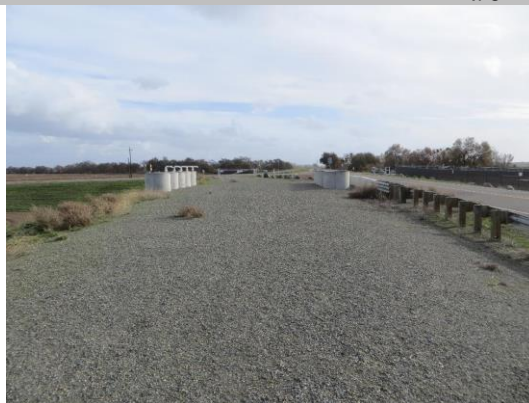
Photo 3 of 3 : UCIP_SP_2017_46971_74874.jpg

Risers located on both sides of levee crown.

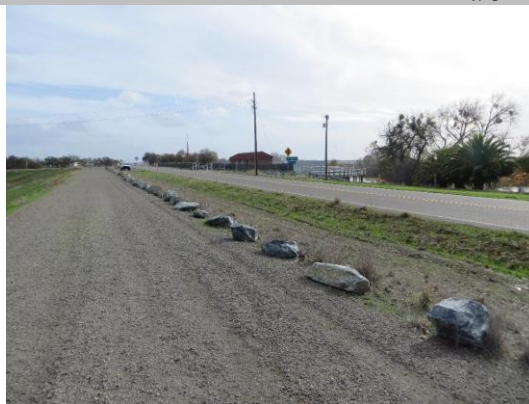
Photo 1 of 3 : UCIP_SP_2017_46972_74877.jpg

LM Start	0.00	Rating **	M	Issue No.	140
LM End	0.00	Issue Type +	En	Location *	WS
Category	Supplemental			GPS Latitude/Longitude	
				Start	End
Item	DWR UCIP Field Study			38.778038 °	38.778038 °
				-121.600790 °	-121.600790 °
DWR ID					
Comment Code					
Inspector Comment					
FS_ID:46972 DS_ID:25428 EP_NO: N/A Repair Type: Non-Urgent Crossing Status: Found UCIP Comments: FIELD_STRUCT_DESC: 3 of 5. [Sankey Diversion Pumping Plant] 48-inch FS Date: 12/10/2015

Overview of levee crown near Sankey Diversion Pumping Plant.

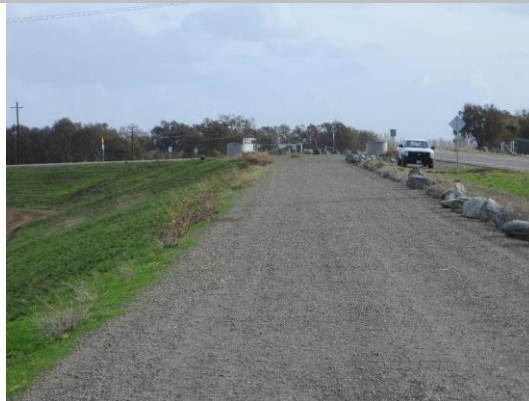
Photo 2 of 3 : UCIP_SP_2017_46972_74878.jpg

View of levee crown.

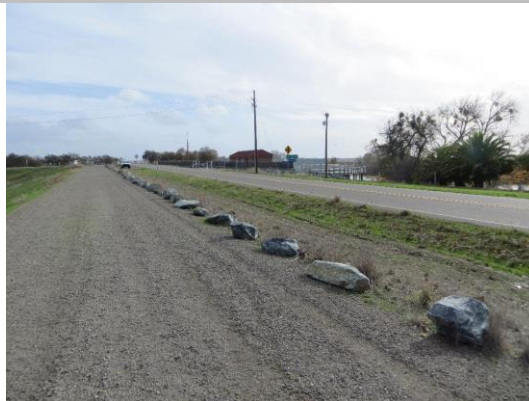
Photo 1 of 3 : UCIP_SP_2017_46973_74882.jpg

LM Start	0.00	Rating **	M	Issue No.	141
LM End	0.00	Issue Type +	En	Location *	WS
Category	Supplemental			GPS Latitude/Longitude	
				Start	End
Item	DWR UCIP Field Study			38.778022 °	38.778022 °
				-121.600777 °	-121.600777 °
DWR ID					
Comment Code					
Inspector Comment					
FS_ID:46973 DS_ID:25429 EP_NO: N/A Repair Type: Non-Urgent Crossing Status: Found UCIP Comments: FIELD_STRUCT_DESC: 4 of 5. [Sankey Diversion Pumping Plant] 48-inch FS Date: 12/10/2015

Overview of levee crown near Sankey Pumping Station.

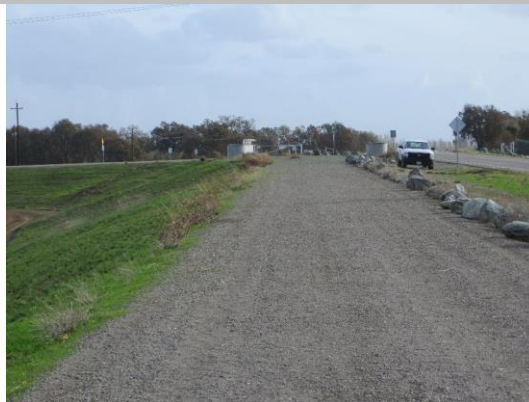
Photo 2 of 3 : UCIP_SP_2017_46973_74883.jpg

View of levee crown.

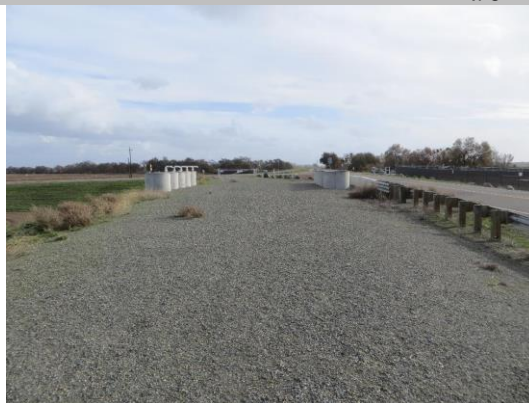
Photo 3 of 3 : UCIP_SP_2017_46973_74884.jpg

Risers located on both sides of the levee crown.

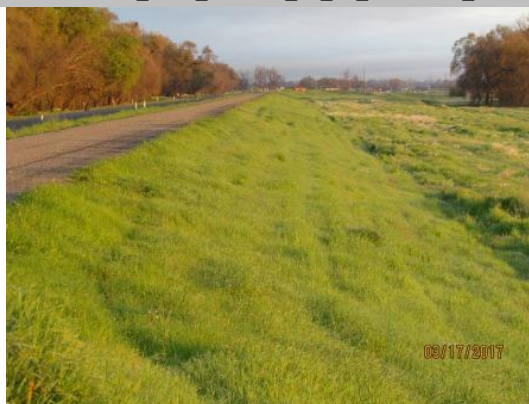
Photo 1 of 1 : SP_2017_RD1000_31_17_20170327_00048.jpg

View of annual grasses land side, that need to be maintained. The RD has started their spraying for spring of 2017.

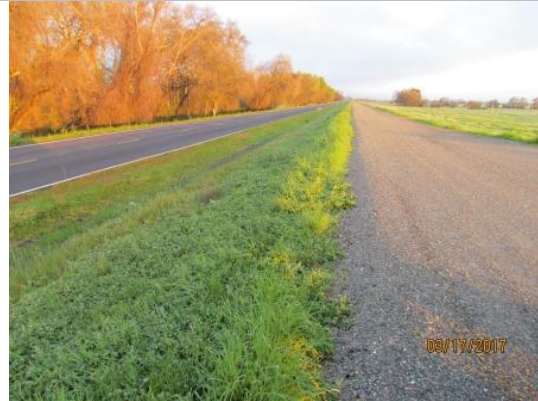
Photo 1 of 1 : SP_2017_RD1000_31_64_20170327_00049.jpg

View of annual grasses water side, that need to be maintained. The RD has started their spraying for spring of 2017.

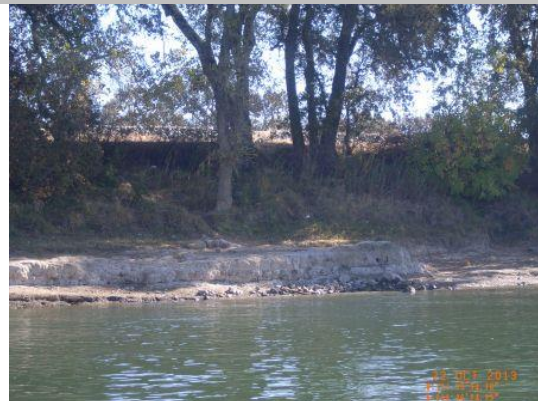
Photo 1 of 1 : SP_2017_RD1000_31_3_20170316_00002.jpg

LM Start	0.48	Rating **	M	Issue No.	3
LM End	0.61	Issue Type +	Ma	Location *	WS
Category	Supplemental			GPS Latitude/Longitude	
				Start	End
Item	2015 USACE Erosion Survey, DRAFT			38.774507 °	38.772921 °
				-121.598865 °	-121.597788 °
DWR ID	DWR_RD1000_01_s_2016_3				
Comment Code					
Inspector Comment					
1997 - Very cohesive toe. 2005 - Site was staked and rock was stockpiled along the top of the bank. 2010 - New adjacent levee under construction. 2011 - New animal burrow. 2015: No observed changes. [2015 Site ID: SAC_78-3_L]

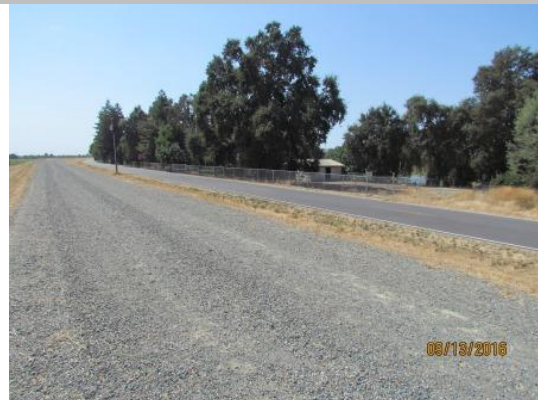
Photo 1 of 1 : SP_2017_RD1000_31_136_20170316_00032.jpg

View of an encroachment, 'Fence'. Fall 2016.

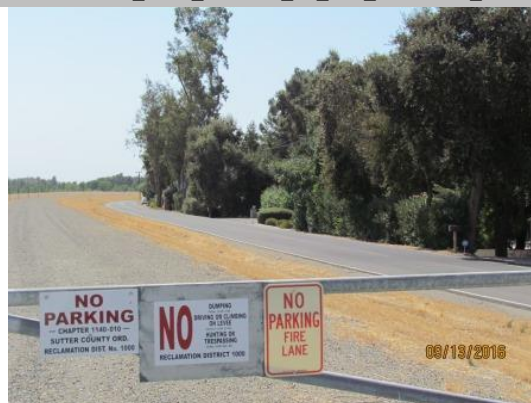
Photo 1 of 1 : SP_2017_RD1000_31_133_20170316_00031.jpg

Typical Garden Hwy 'Landscaping'. Fall 2016.

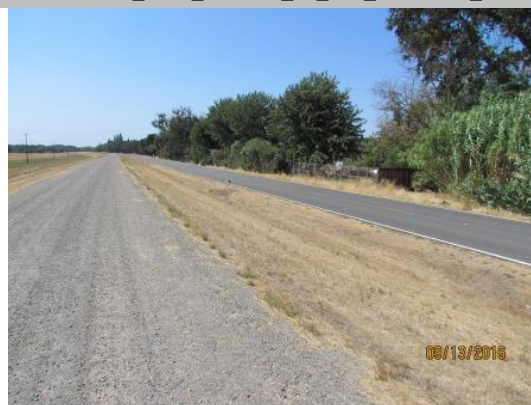
Photo 1 of 1 : SP_2017_RD1000_31_120_20170316_00030.jpg

Typical vegetation along the waterside in front of residences. Fall 2016.

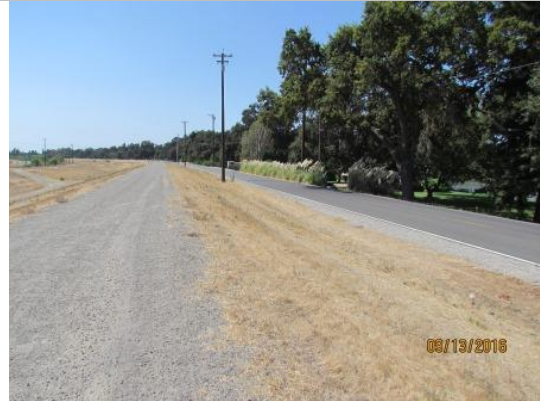
Photo 1 of 1 : SP_2017_RD1000_31_111_20170316_00028.jpg

This photo was taken from the crown facing downstream looking down the waterward levee slope at unacceptable landscaping. Fall 2016.

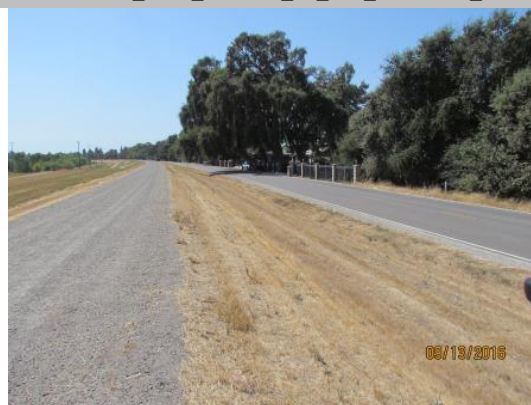
Photo 1 of 1 : SP_2017_RD1000_31_108_20170316_00027.jpg

View of an encroachment fence. Fall 2016.

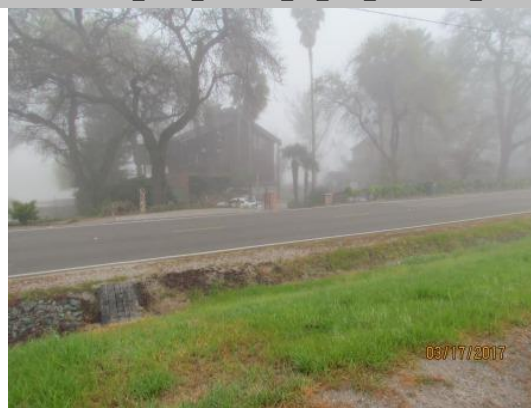
Photo 1 of 1 : SP_2017_RD1000_31_105_20170327_00050.jpg

View of vegetation that has been trimmed back by property owner and there is clear line of sight.

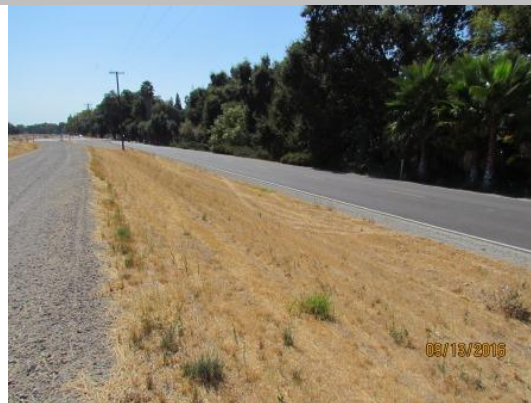
Photo 1 of 1 : SP_2017_RD1000_31_63_20170316_00018.jpg

This photo was taken facing the waterside of the levee looking downstream of typical vegetation in front of residence. Fall 2016.

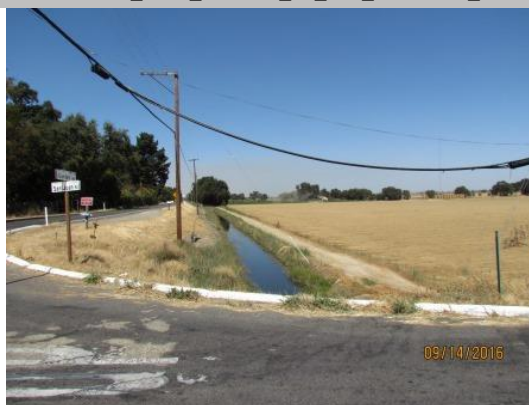
Photo 1 of 1 : SP_2017_RD1000_31_101_20170316_00026.jpg

View looking upstream at ditch on landside toe.

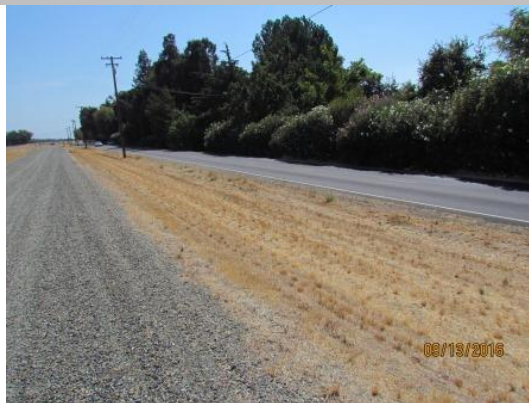
Photo 1 of 1 : SP_2017_RD1000_31_82_20170316_00024.jpg

This photo was taken from the crown facing downstream waterside levee slope at unacceptable landscaping. Fall 2016.

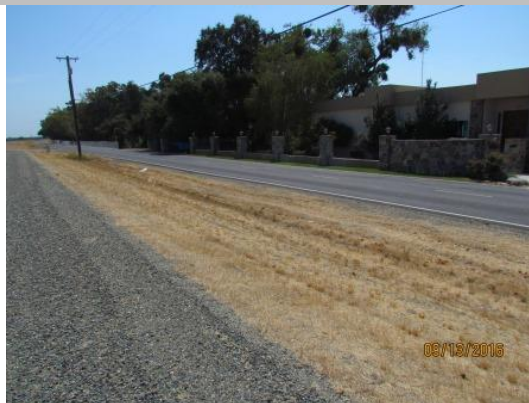
Photo 1 of 1 : SP_2017_RD1000_31_2_20170316_00001.jpg

This photo was taken during Fall 2015 from the crown facing downstream on the waterward levee slope at an enforcement issue with this fence, per the NOV all panels of the fence are to be removed. The owner has remove some of the panels between the post. Spring 2017.

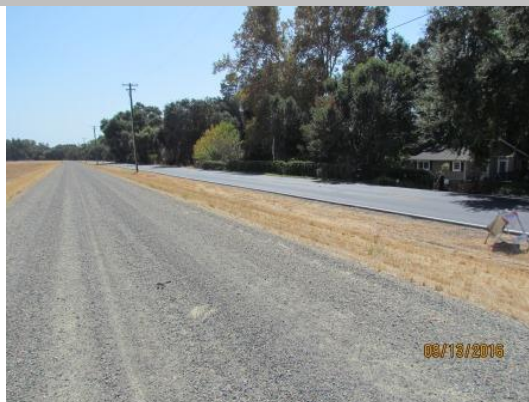
Photo 1 of 1 : SP_2017_RD1000_31_74_20170316_00022.jpg

This photo was taken from the crown facing downstream looking down the waterward levee slope at unacceptable landscaping. Fall 2016.

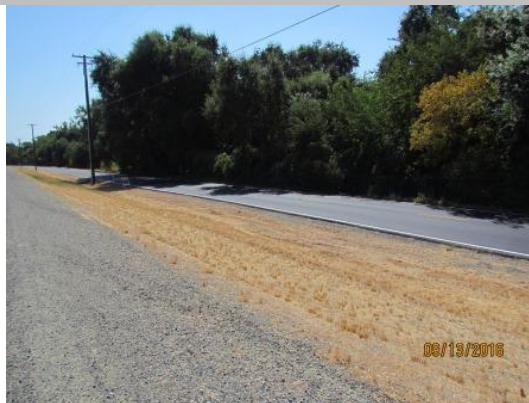
Photo 1 of 1 : SP_2017_RD1000_31_73_20170316_00021.jpg

This photo was taken from the crown facing downstream looking down the waterward levee slope at unacceptable landscaping. Fall 2016.

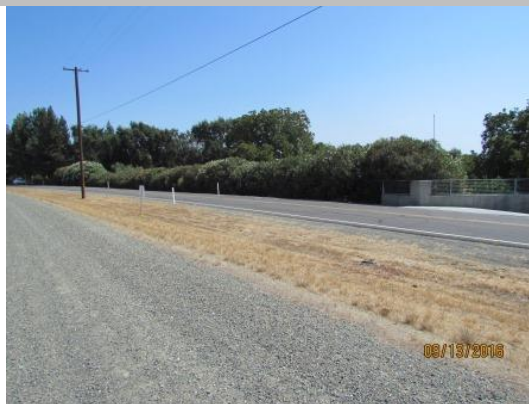
Photo 1 of 1 : SP_2017_RD1000_31_70_20170316_00020.jpg

This photo was taken from the crown facing downstream looking down the waterward levee slope at unacceptable landscaping. Fall 2016.

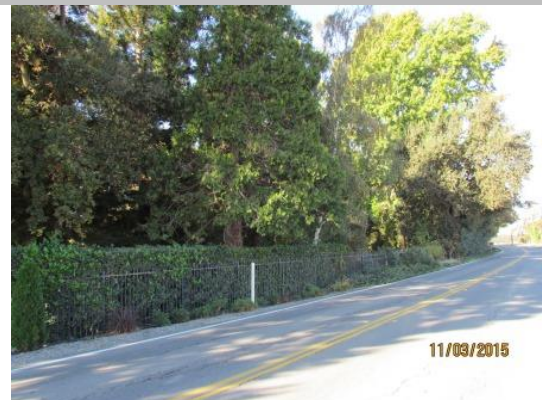
Photo 1 of 1 : SP_2017_RD1000_31_66_20170316_00019.jpg

View of the landscaping on the waterside levee slope.

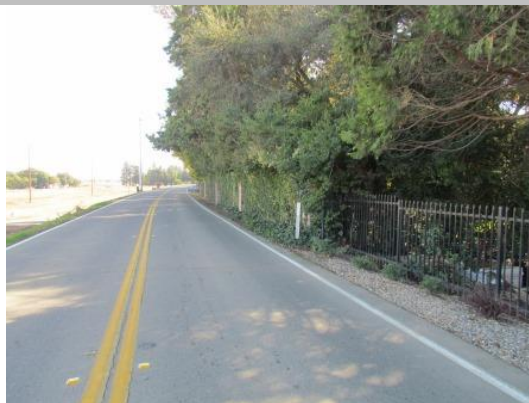
Photo 1 of 1 : SP_2017_RD1000_31_62_20170316_00017.jpg

This photo was taken from the crown facing downstream looking down the waterward levee slope at unacceptable landscaping. Fall 2014.

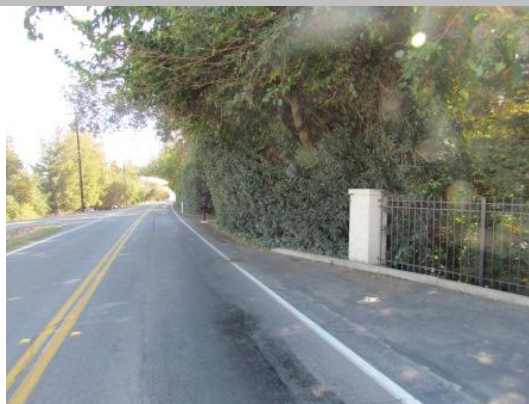
Photo 1 of 1 : SP_2017_RD1000_31_60_20170316_00016.jpg

This photo was taken from the crown facing downstream looking down the waterward levee slope at unacceptable landscaping. Fall 2014.

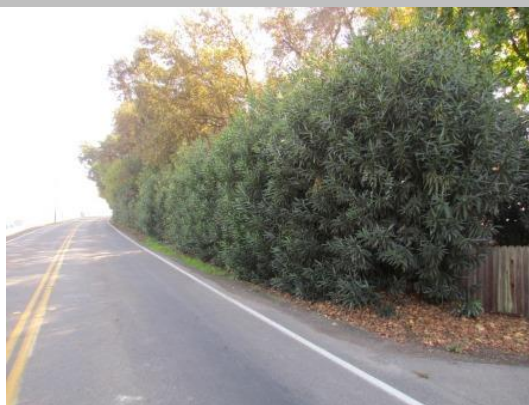
Photo 1 of 1 : SP_2017_RD1000_31_58_20170316_00015.jpg

This photo was taken from the crown facing downstream looking down the waterward levee slope at unacceptable landscaping. Fall 2014.

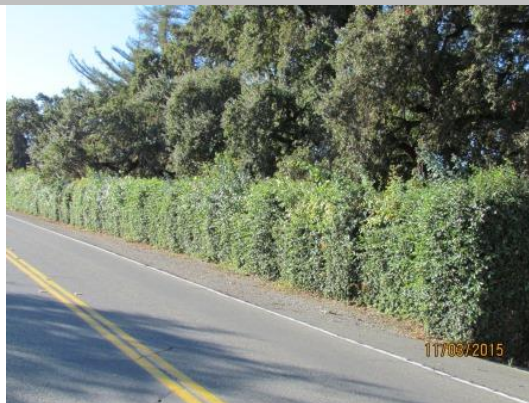
Photo 1 of 1 : SP_2017_RD1000_31_51_20170316_00013.jpg

View of the landscaping on the waterside levee slope.

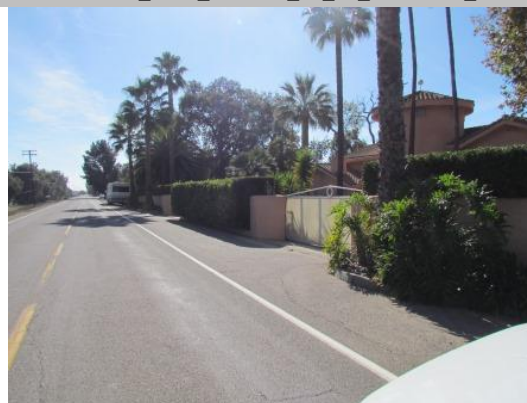
Photo 1 of 1 : SP_2017_RD1000_31_43_20170316_00012.jpg

This photo was taken from the crown facing downstream looking down the waterward levee slope at an unacceptable fence. Fall 2014.

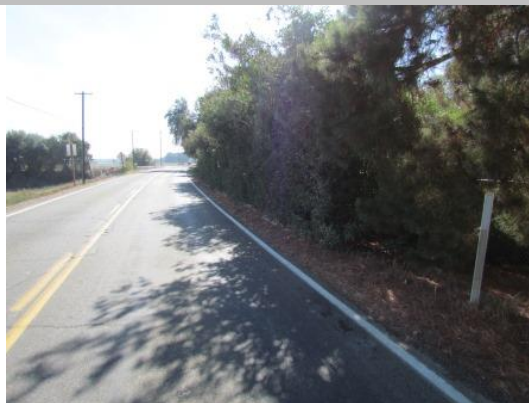
Photo 1 of 1 : SP_2017_RD1000_31_42_20170316_00011.jpg

This photo was taken from the crown facing downstream looking down the waterward levee slope at unacceptable landscaping. Fall 2014.

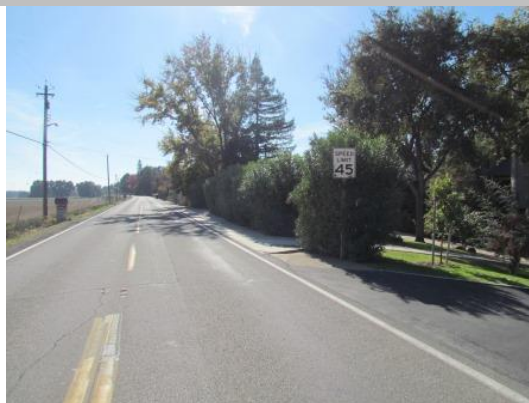
Photo 1 of 1 : SP_2017_RD1000_31_40_20170316_00010.jpg

This photo was taken from the crown facing downstream looking down the waterward levee slope at unacceptable landscaping. Fall 2014.

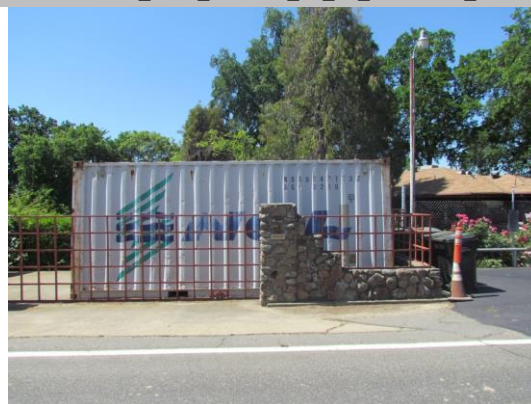
Photo 1 of 1 : SP_2017_RD1000_31_53_20170316_00014.jpg

View of storage container from the landside of the crown facing the waterside of the levee.

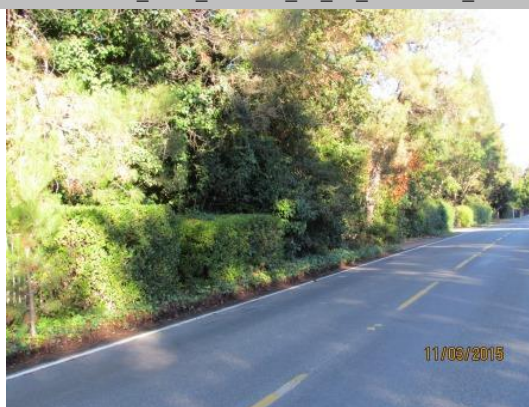
Photo 1 of 1 : SP_2017_RD1000_31_35_20170316_00009.jpg

View of the landscaping on the waterside levee slope.

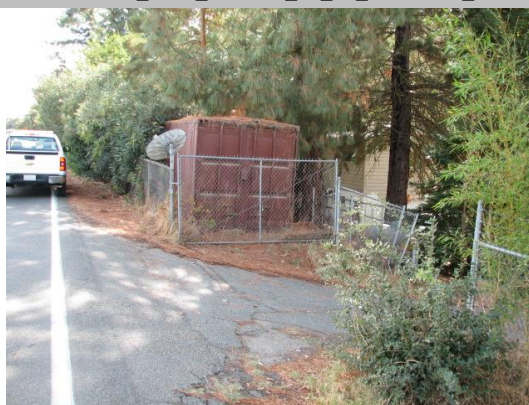
Photo 1 of 1 : SP_2017_RD1000_31_76_20170316_00023.jpg

Cargo container on levee shoulder, the property appears to be on fill material.

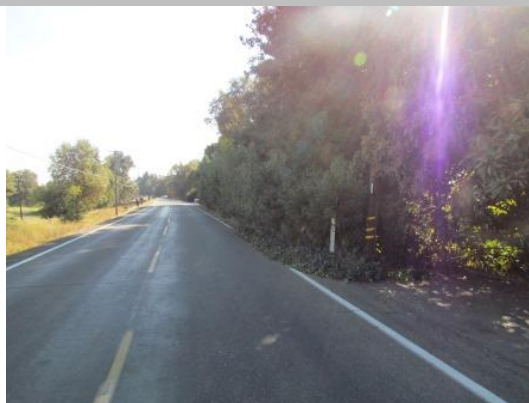
Photo 1 of 1 : SP_2017_RD1000_31_31_20170316_00008.jpg

This photo was taken from the crown facing downstream looking down the waterward levee slope at unacceptable landscaping. Fall 2014.

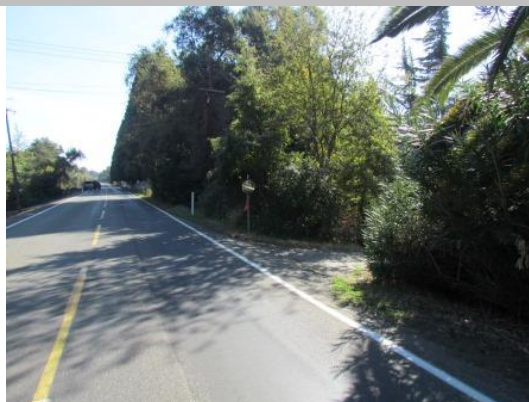
Photo 1 of 1 : SP_2017_RD1000_31_30_20170316_00007.jpg

This photo was taken from the crown facing down stream looking down the waterward levee slope at unacceptable landscaping. Fall 2014.

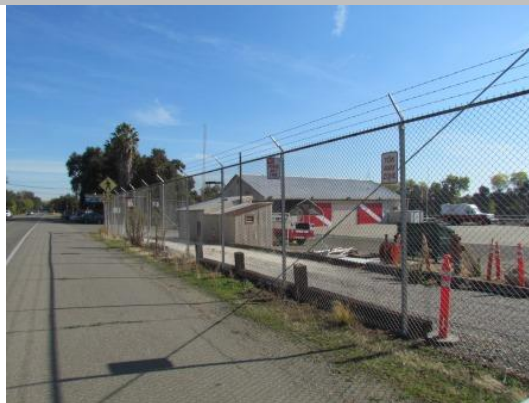
Photo 1 of 1 : SP_2017_RD1000_31_8_20170316_00004.jpg

This photo was taken from the crown facing downstream looking down the waterward levee slope at an unacceptable building. Fall 2014.

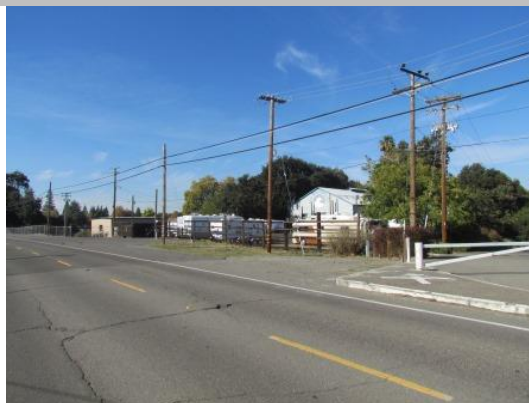
Photo 1 of 1 : SP_2017_RD1000_31_9_20170316_00005.jpg

This photo was taken from the crown facing upstream looking down the landward levee slope at an unacceptable building. Fall 2014.

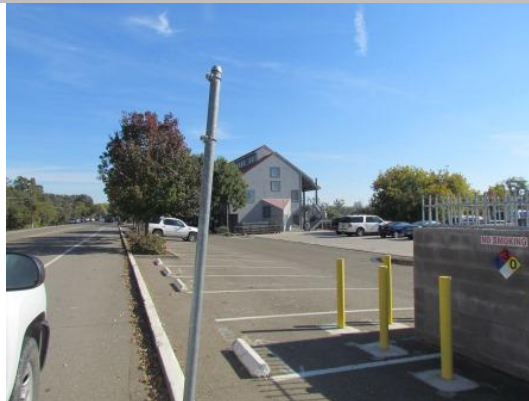
Photo 1 of 1 : SP_2017_RD1000_31_5_20170316_00003.jpg

This photo was taken from the crown facing downstream looking down the waterward levee slope at an unacceptable building. Fall 2014.

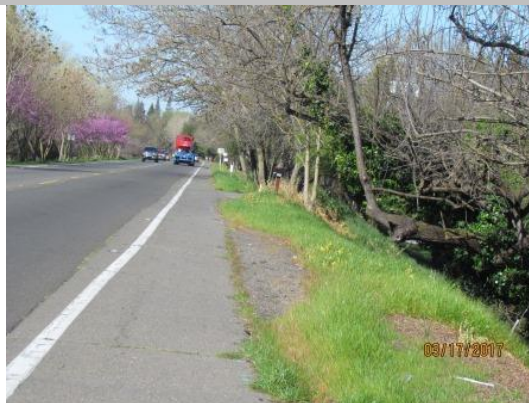
Photo 1 of 1 : SP_2017_RD1000_32_5_20170327_00007.jpg

View of annual grass land side, that are starting to get to tall, the RD has started their spraying, Spring 2017.

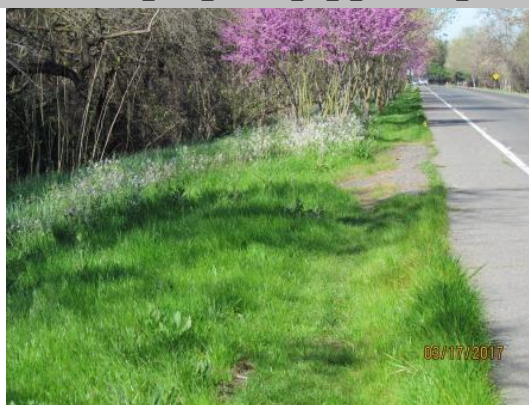
Photo 1 of 1 : SP_2017_RD1000_32_6_20170327_00008.jpg

View of annual grass water side, that are starting to get to tall, the RD has started their spraying, Spring 2017.

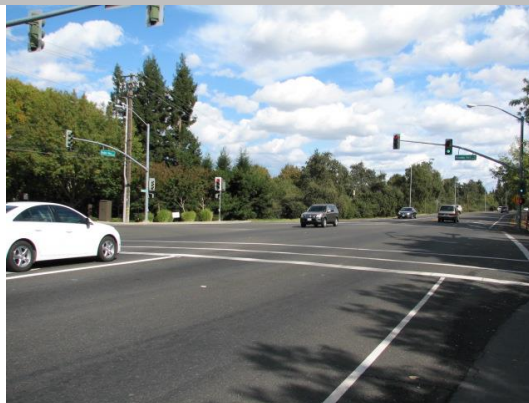
Photo 1 of 3 : SP_2017_RD1000_32_1_20170316_00001.jpg

Levee mile 0.56. This photo is looking upstream from the waterside levee shoulder to the landside shoulder.

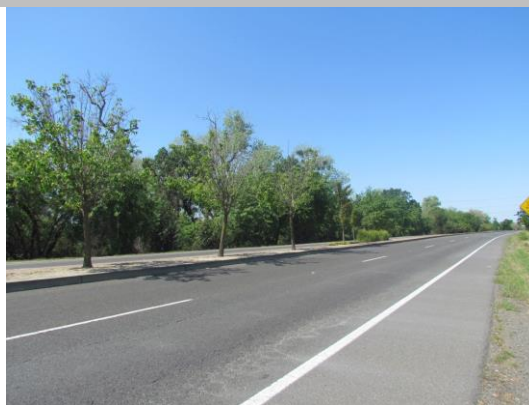
Photo 2 of 3 : SP_2017_RD1000_32_1_20170316_00002.jpg

Taken on the landside facing the waterside looking downstream.

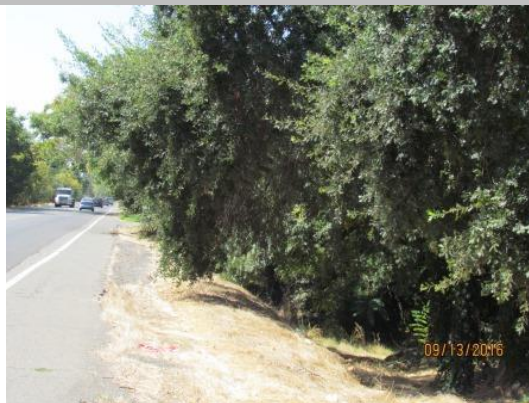
Photo 1 of 1 : SP_2017_RD1000_32_4_20170316_00006.jpg

View looking downstream landside of trees that need to be trimmed. Fall 2016.

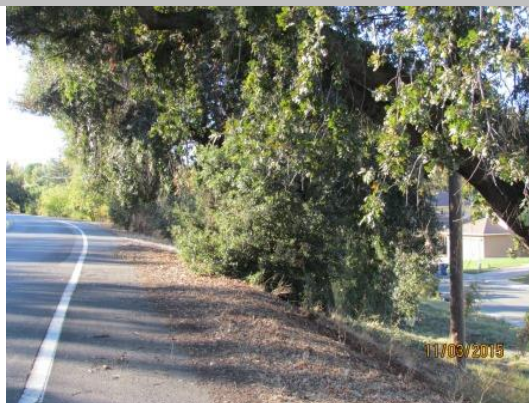
Photo 1 of 1 : SP_2017_RD1000_32_2_20170316_00004.jpg

View of the trees on the landside levee slope. Small trees 4" in diameter at chest height should be removed before they get to big.

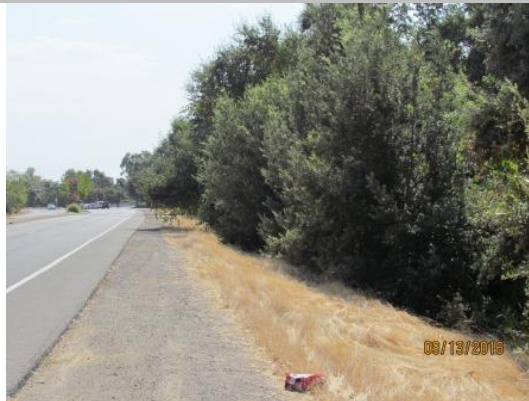
Photo 1 of 1 : SP_2017_RD1000_32_3_20170316_00005.jpg

View looking upstream waterside of trees that need to be trimmed. Fall 2016.

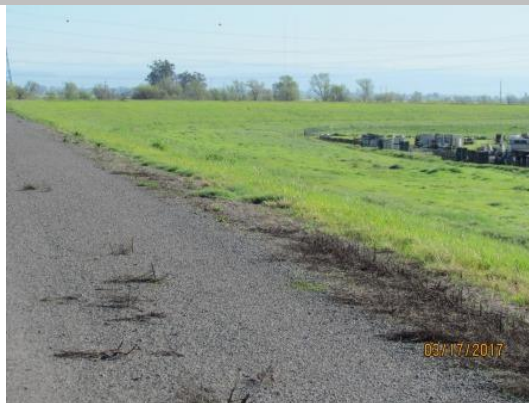
Photo 1 of 1 : SP_2017_RD1000_33_6_20170327_00017.jpg

View of annual grass land side, that are starting to get a little to tall, the RD has started their spraying, Spring 2017.

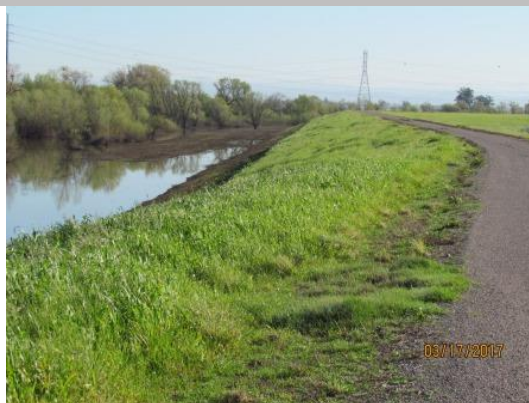
Photo 1 of 1 : SP_2017_RD1000_33_11_20170327_00018.jpg

View of annual grass water side, that are starting to get a little to tall, the RD has started their spraying, Spring 2017.

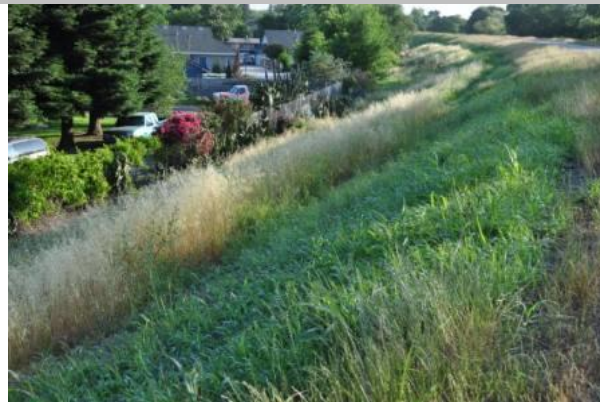
Photo 1 of 2 : SP_2017_RD1000_33_7_20170316_00005.jpg

Fence with vegetation at L/S toe.

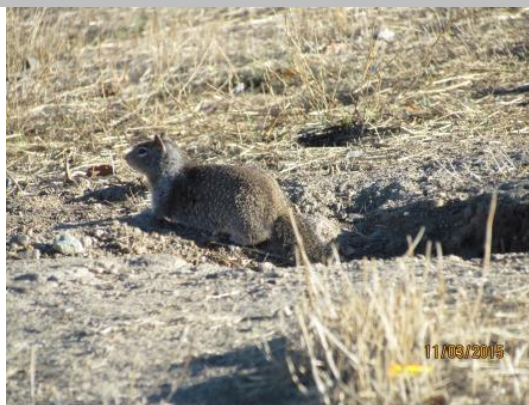
Photo 2 of 2 : SP_2017_RD1000_33_19_20170316_00014.jpg

View of the rodent on the waterside levee slope ready to retreat into the den, penetrating the levee prism.

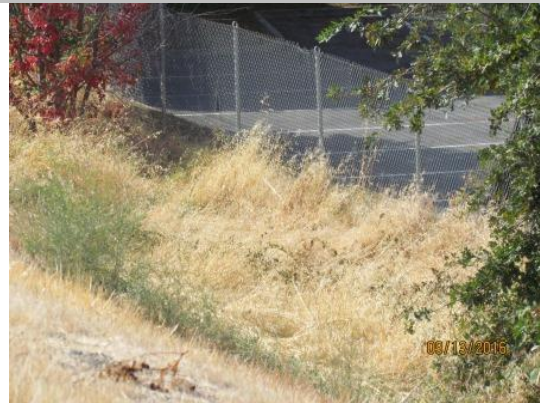
Photo 1 of 1 : SP_2017_RD1000_33_17_20170316_00012.jpg

View of fence at landside levee toe.

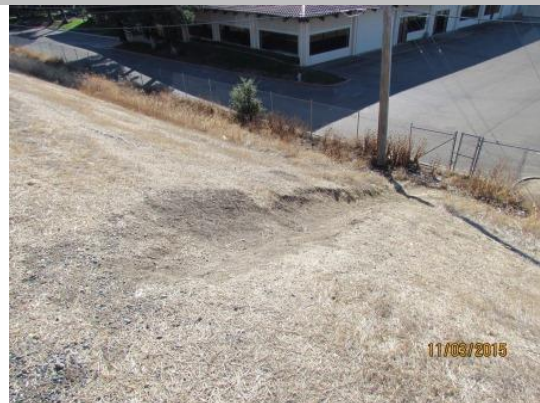
Photo 1 of 1 : SP_2017_RD1000_33_15_20170316_00011.jpg

View of the landside levee slope damaged by foot traffic.

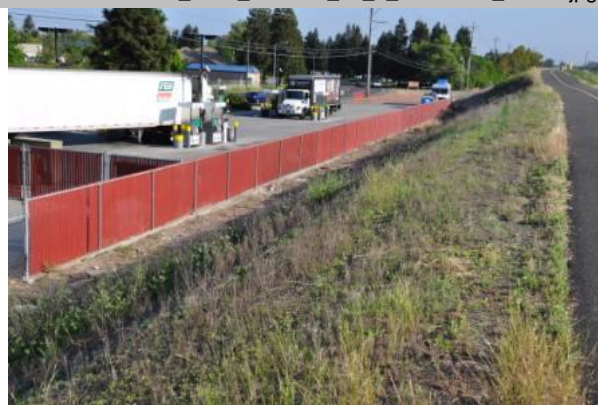
Photo 1 of 1 : SP_2017_RD1000_33_3_20170316_00004.jpg

Fence within 10' of L/S toe.

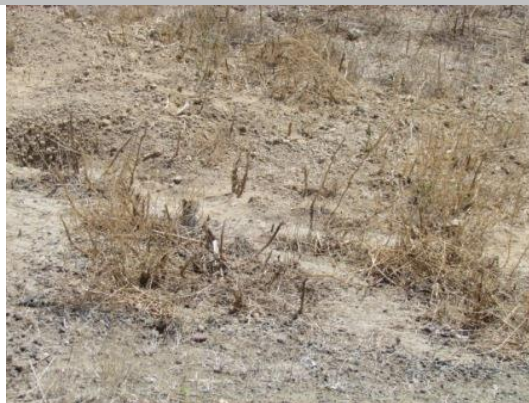
Photo 1 of 2 : SP_2017_RD1000_33_1_20170316_00001.jpg

This photo was taken from the levee crown looking down the landward slope at a squirrel poking its head out of a hole. Fall 2014.

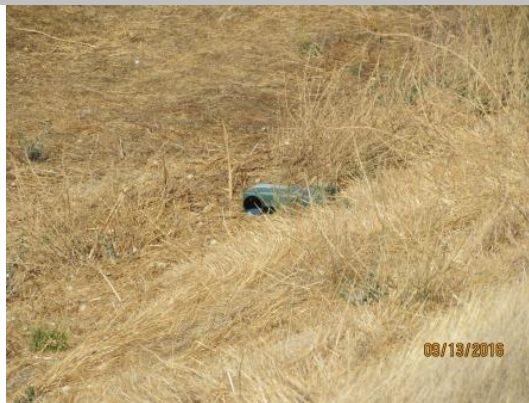
Photo 2 of 2 : SP_2017_RD1000_33_1_20170316_00002.jpg

Updated view taken facing the landside looking upstream at bait trap.
Rodent holes have been filled and no new activity was observed.
Several bait traps at landside levee toe. Fall 2016.

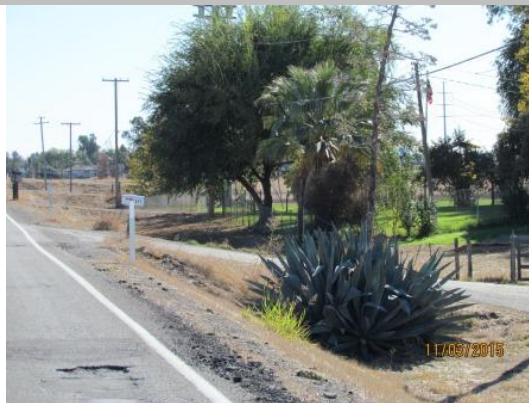
Photo 1 of 1 : SP_2017_RD1000_33_2_20170316_00003.jpg

View of the landscaping at the landside levee toe.

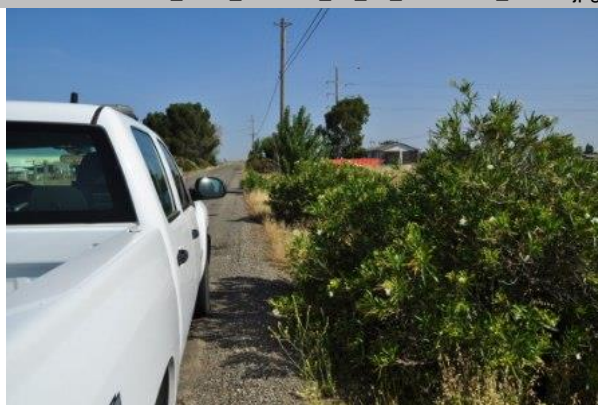
Photo 1 of 1 : SP_2017_RD1000_33_10_20170316_00009.jpg

WS vegetation.

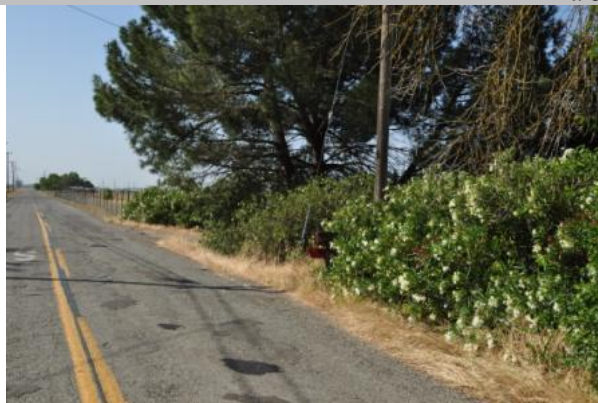
Photo 1 of 1 : SP_2017_RD1000_33_13_20170316_00010.jpg

LS landscaping.

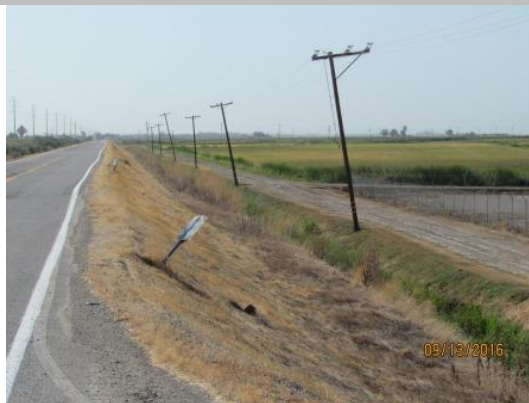
Photo 1 of 1 : SP_2017_RD1000_33_22_20170316_00016.jpg

View of landside ditch at toe of levee, looking downstream.

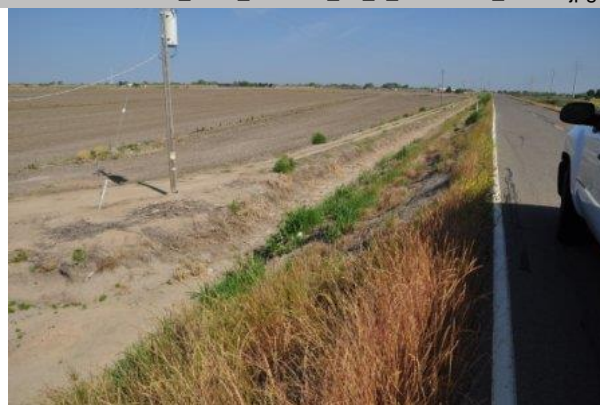
Photo 1 of 1 : SP_2017_RD1000_33_9_20170316_00008.jpg

LS Ag ditch at the LS toe.

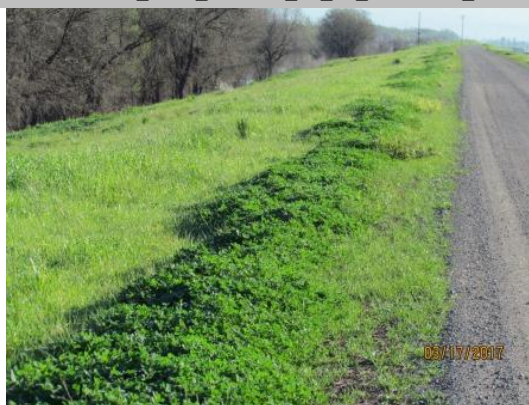
Photo 1 of 1 : SP_2017_RD1000_34_14_20170327_00002.jpg

View of annual grass water side, that are starting to get a little to tall, the RD has started their spraying, Spring 2017.
